May 10, 2012

Nichols Project No. 12-092-CFC

RE: Hazardous Building Materials Assessment
Five Corners Site
10231 - 95th Street and 9440 Jasper Avenue
Edmonton, Alberta

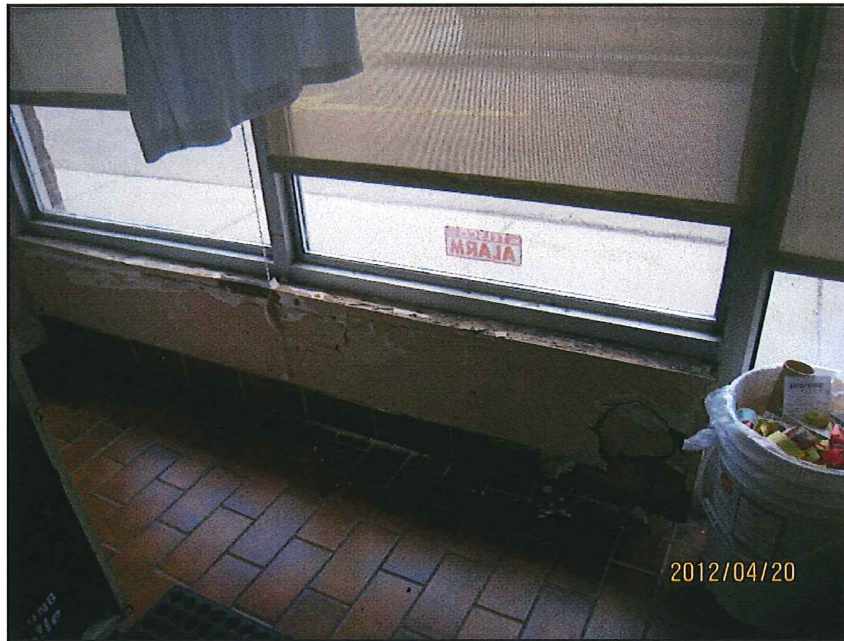
During the inspection, evidence of mould was identified within The Press Gallery building on one of the ceiling tiles outside of the bathroom. The mould is believed to be the result of repeated exposure to condensation from a plastic vent pipe above the ceiling tiles. Water damage was also noted along the east-facing window sills in this building, also likely a result from condensation on the windows from high humidity in the building during the winter months.

Photograph 1: Moisture damage beneath the east-facing windows within The Press Gallery building.

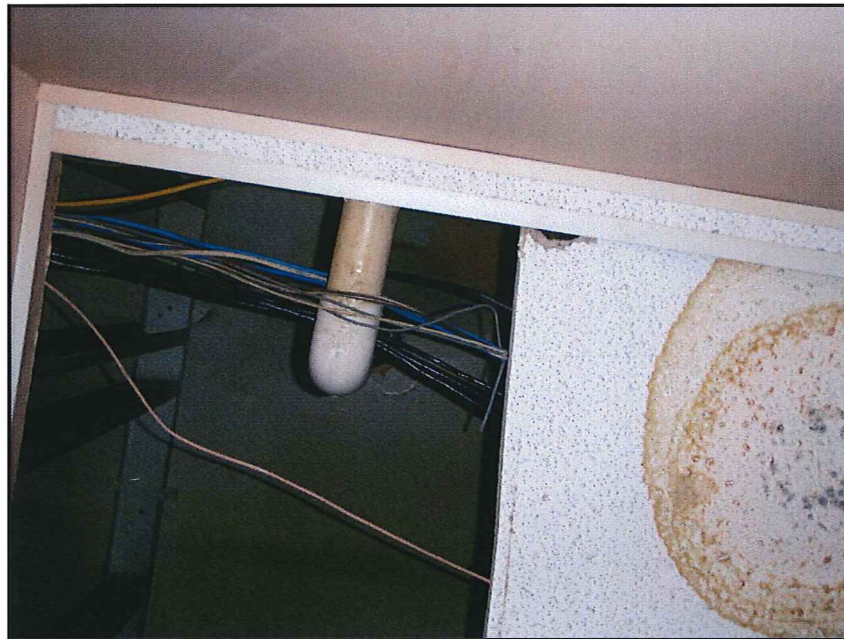
Based on the mould analysis, the total spore concentration found in the background sample (Outside) was similar to that found at the office and window sample locations inside The Press Gallery. However, an elevated *Penicillium/Aspergillus* spore count was reported from the Back Office sample (640 Ct/m³) when compared to the Background sample (320 Ct/m³). This is likely

from the mould present on the ceiling tile directly beneath the vent pipe. Removal of the affected ceiling tile will likely mitigate the elevated spore count in this area.

Photograph 2: Potential mould growth on the ceiling tile (right) likely due to repeated exposure to moisture due to condensation from the vent pipe, within The Press Gallery building.

Evidence of mould growth on a ceiling tile was observed along with elevated *Penicillium/Aspergillus* concentrations near a small office within The Press Gallery when compared to outdoor ambient air. The ceiling tile should be removed and disposed of to mitigate this source of mould spores. Evidence of water damage was also noted beneath the windows at The Press Gallery, likely as a result of condensation. If the commercial unit is to be utilized in the future, consideration should be given to mitigating the vent pipe and windows to prevent water damage and favourable conditions for mould growth from condensation.

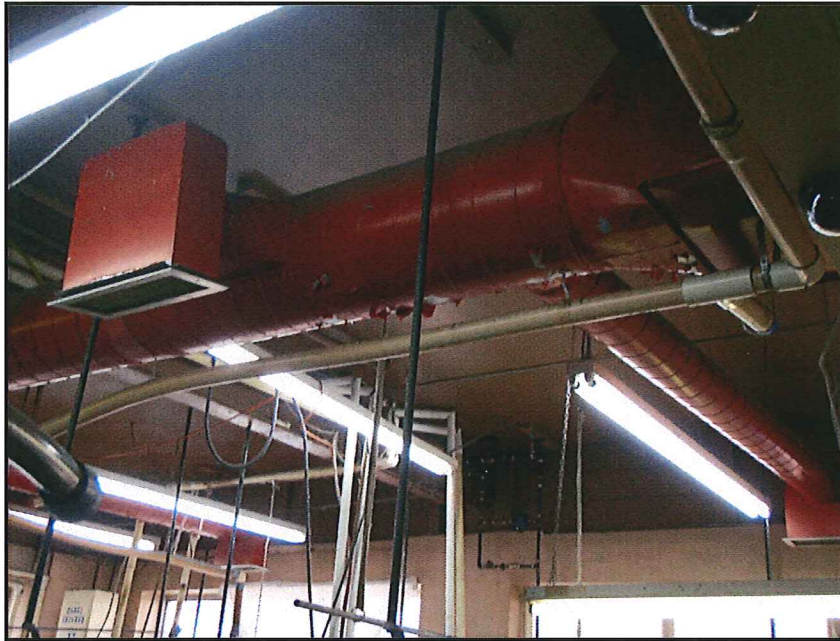
Photograph 3: Peeling paint observed on the overhead ventilation system within The Press Gallery building. This paint did not contain significant concentrations of lead.

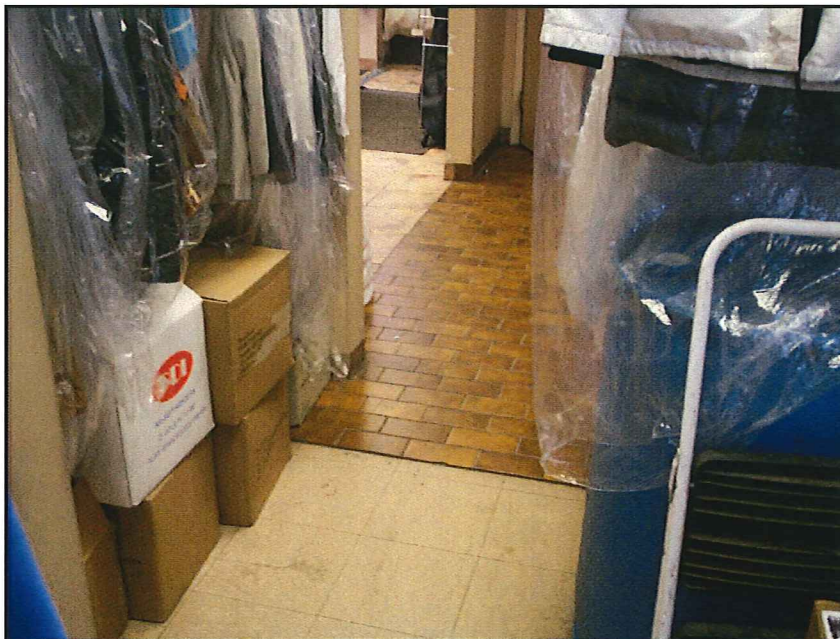
Photograph 4: Three different types of flooring found within The Press Gallery building, none of which was identified to contain asbestos.

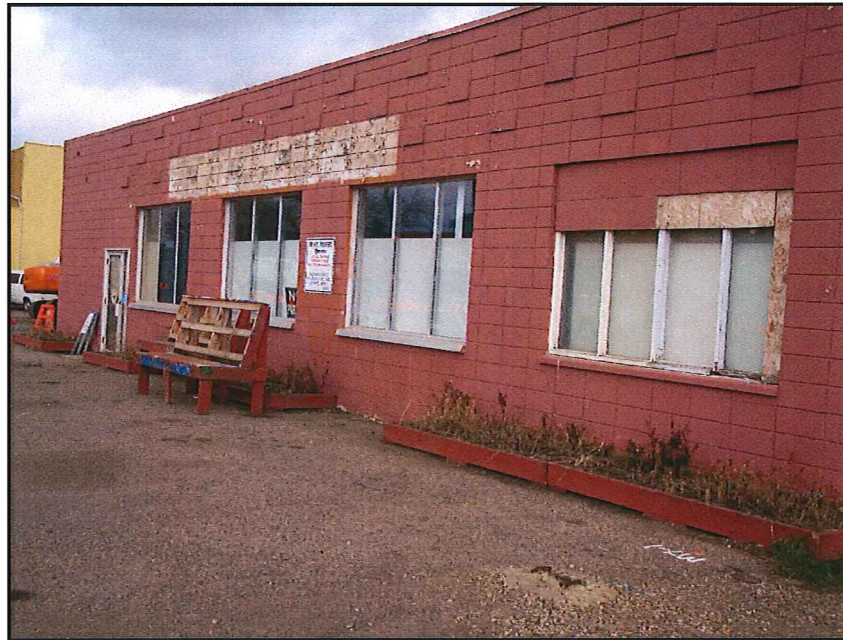
The exterior paint sampled from the former iHuman building (SB-01 blue and SB-02 red exterior) had elevated concentrations of lead ranging from 810 to 924 mg/kg, which is above the consumer limits of 600 mg/kg. Paint samples were also collected from ceiling vents (SA-03 and SA-04) within The Press Gallery building and walls, which did not identify any significant concentrations of lead.

Based on the information collected to date, exterior paint on the west wall on the former iHuman building had elevated concentrations of lead ranging from 810 to 924 mg/kg, which is above the consumer limits of 600 mg/kg. Two mercury-containing thermostats were also identified within this building.

Photograph 5: West exterior of the former iHuman building. Paint samples were identified to contain elevated levels of lead.

No further testing or abatement is recommended with respect to the hazardous building materials with the exception of being aware of the lead-based paint present on the exterior of the former iHuman building and following recommended handling and disposal procedures during any demolition or renovation works.

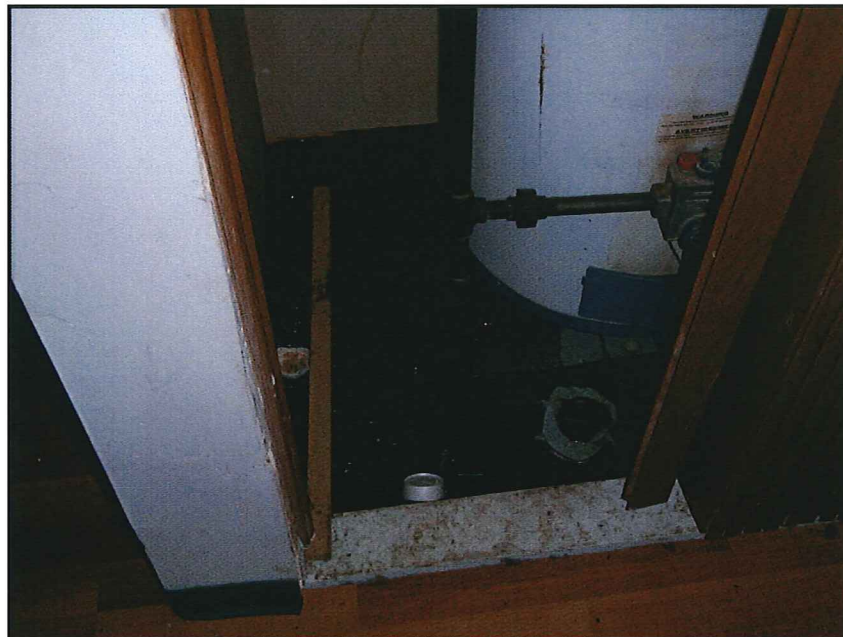
Water damage was identified within the former iHuman building in the vicinity of a hot water tank which appeared to have ruptured at some point in time prior to the site inspection. Water was still present at this location and should be removed as the warmer temperatures will provide favourable conditions for mould growth. Water damage was also noted within portions of the washrooms in the former iHuman building.

Photograph 6: Moisture/water damage within the former iHuman building, likely due to a ruptured water heater.

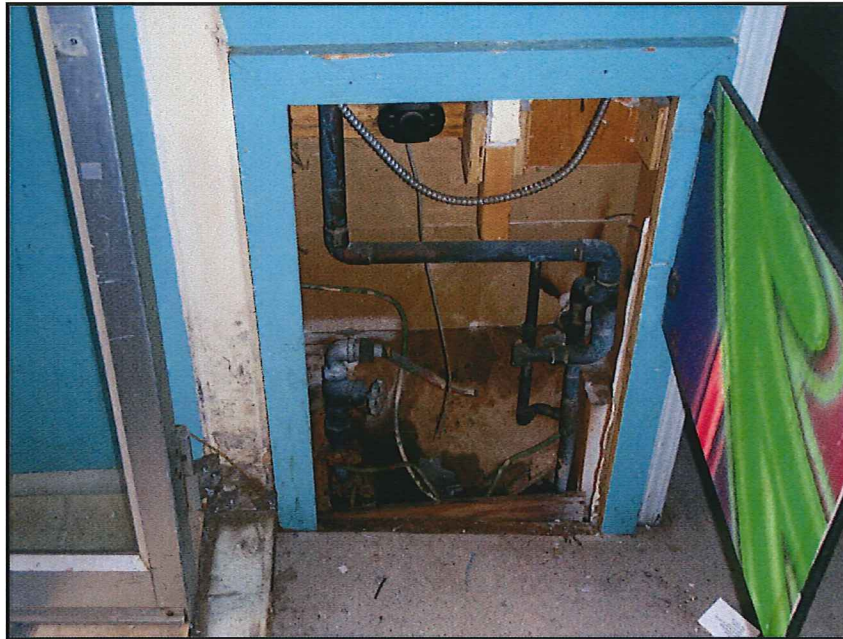
Photograph 7: Water damage likely due to leaking piping within the former iHuman building.

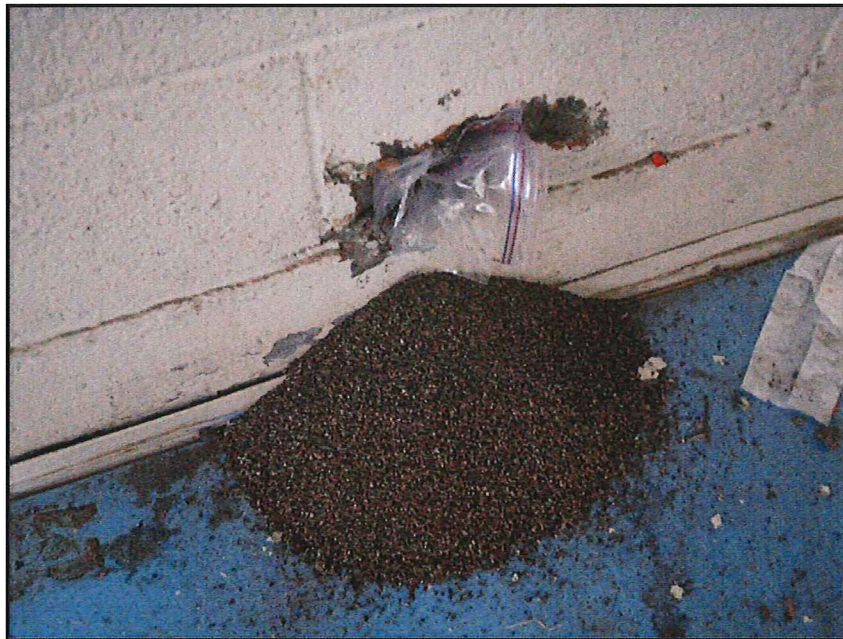
In total, ten samples were collected from various building materials within the buildings, including ceiling tile, pipe insulation, drywall mud, grout, floor tile, stucco and the vermiculite insulation identified within the cinder block wall of the former iHuman building. Of the ten samples submitted, none were found to contain asbestos, including the vermiculite insulation.

Photograph 8: Vermiculite insulation identified within the exterior cinder-block walls of the former iHuman building. Tested vermiculite insulation did not contain asbestos.
