**Re: Geotechnical Investigation  
Proposed East Schonsee Subdivision  
Block C, Plan 2887AQ  
16704 - 66 Street NW  
Edmonton, Alberta**

**REPORT NO: 6004 – 28**

**GEOTECHNICAL INVESTIGATION  
PROPOSED EAST SCHONSEE SUBDIVISION  
BLOCK C, PLAN 2887AQ  
16704 – 66 STREET NW  
EDMONTON, ALBERTA**

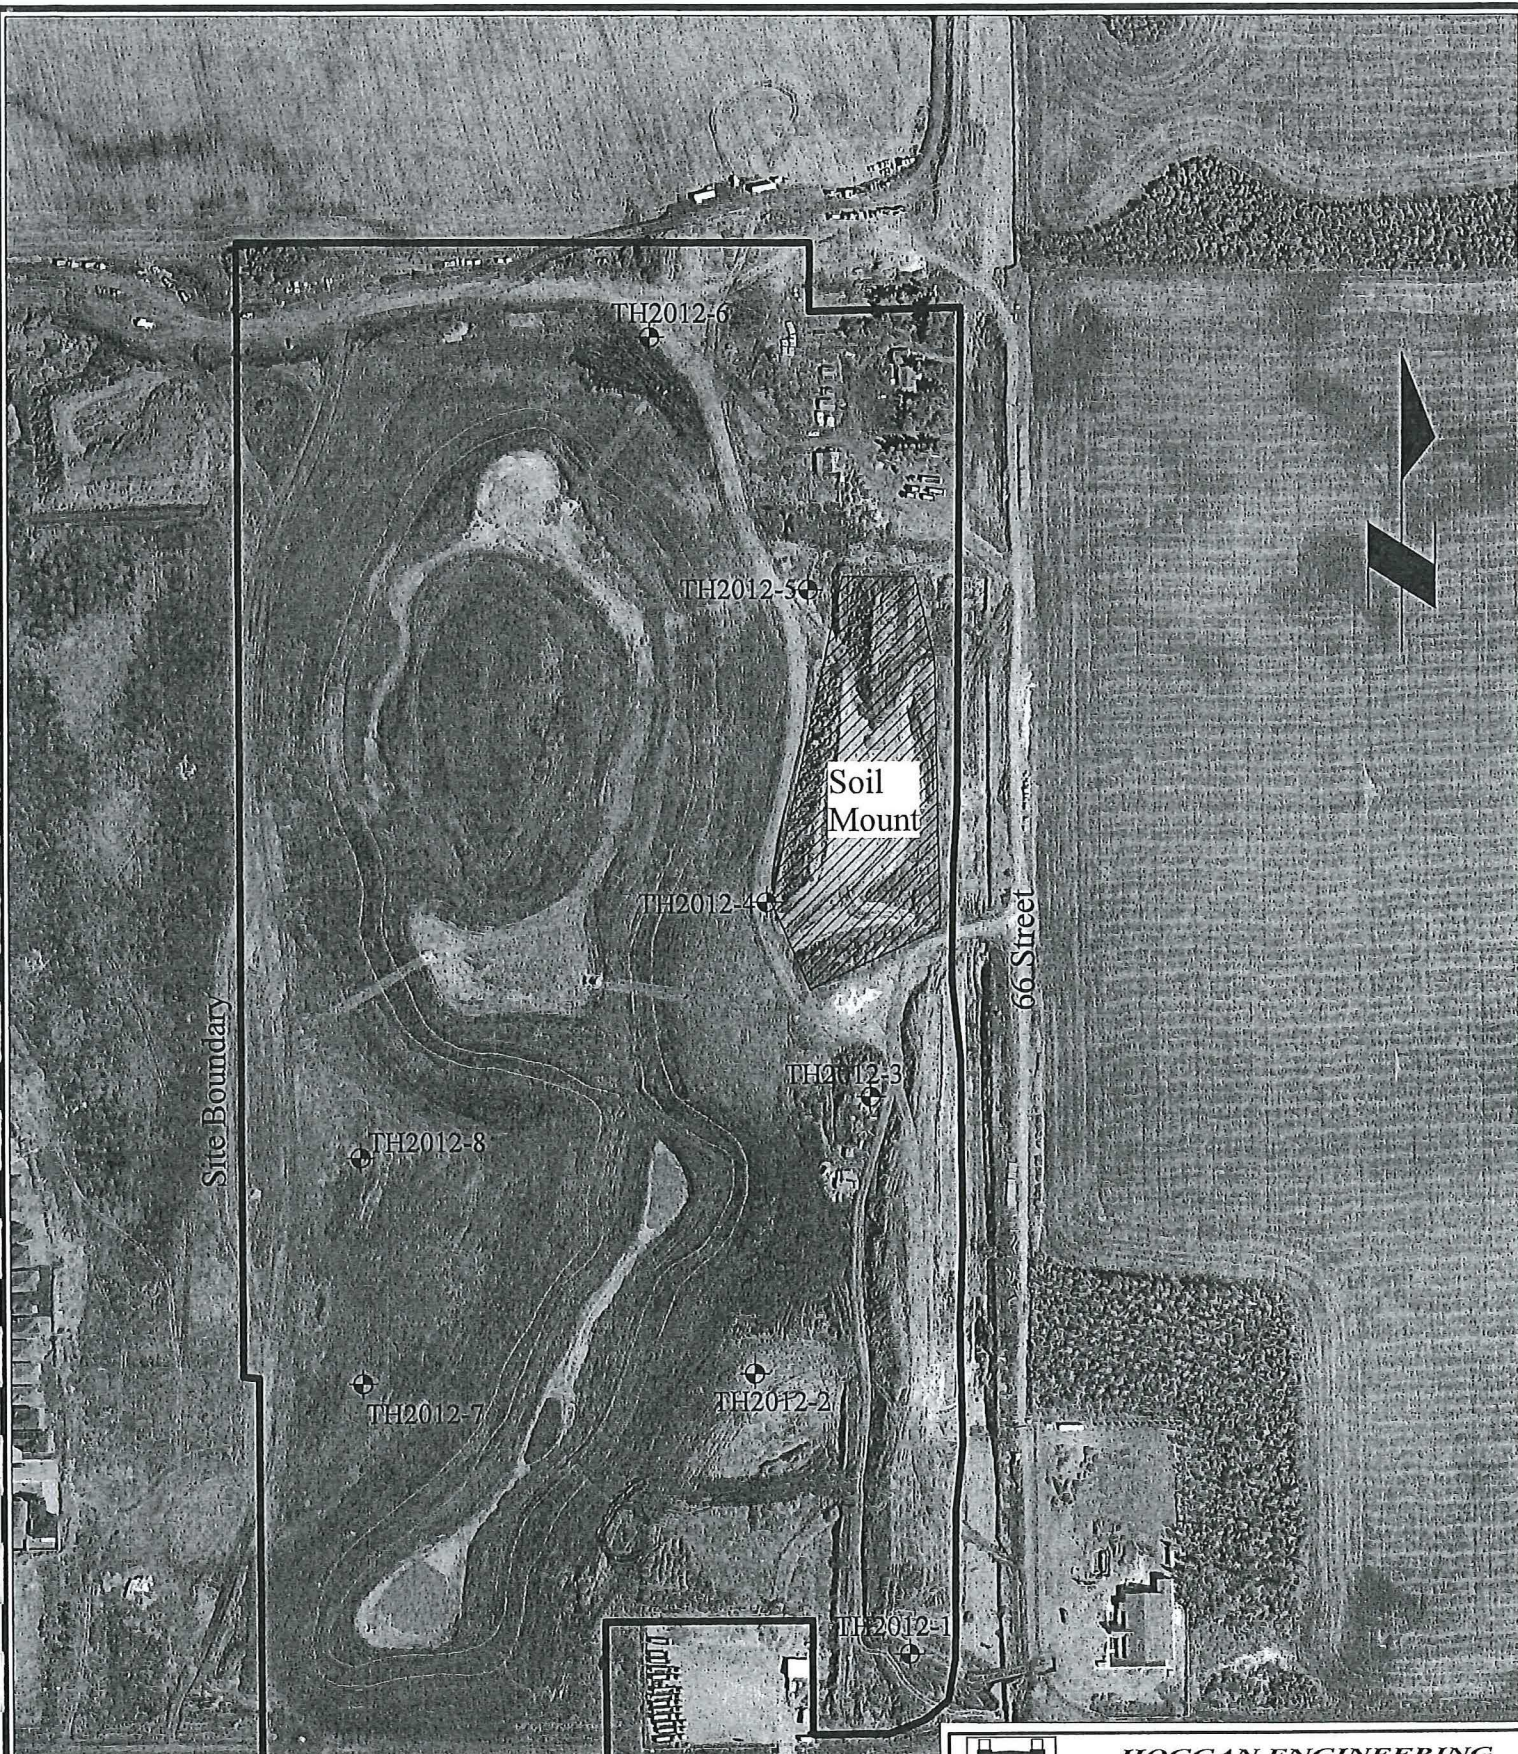
Figure 1

Site Boundary

Soil Mount

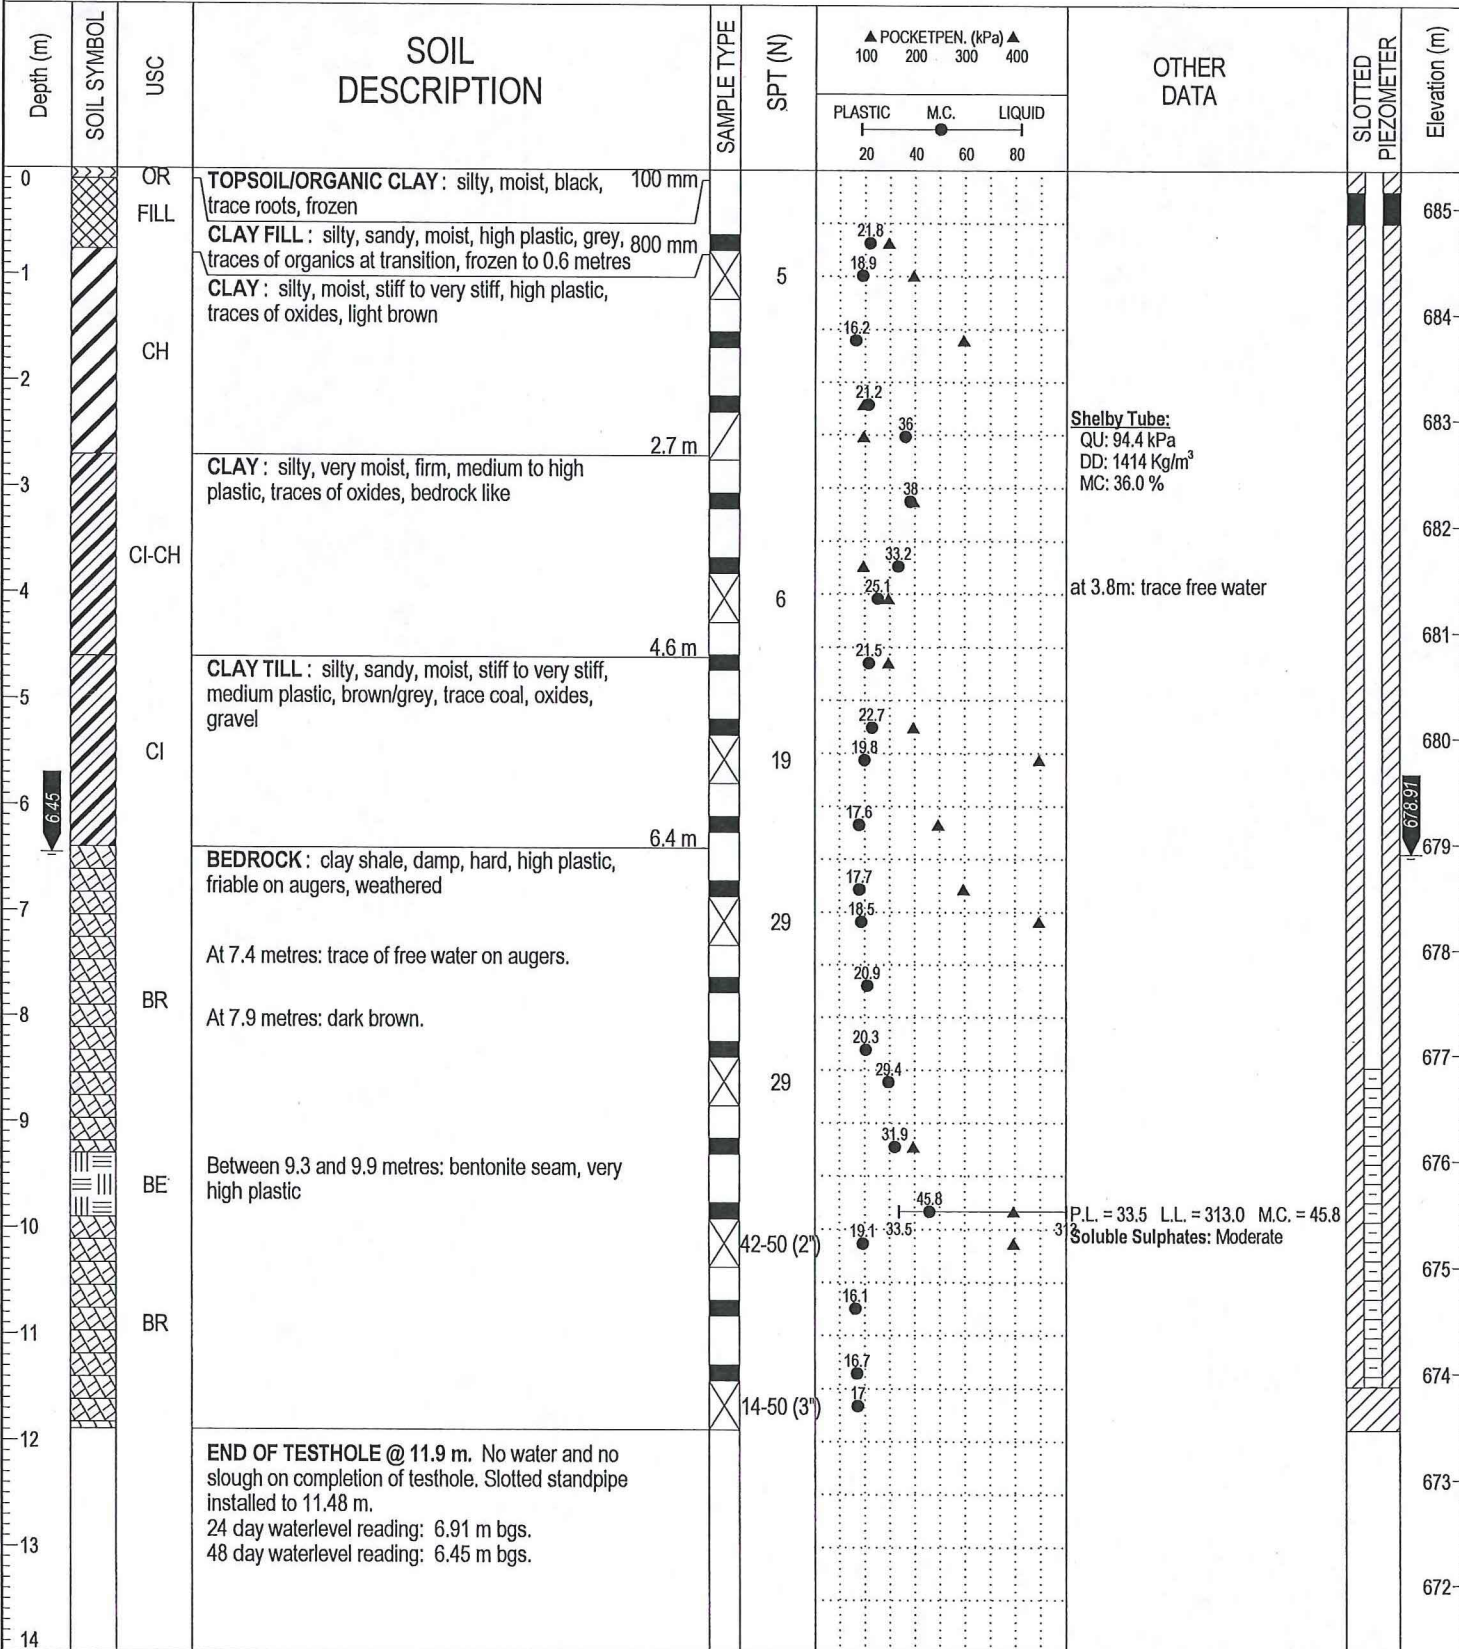
PROJECT: Geotechnical Investigation - Proposed East Schonsee Subdivision		PROJECT NO: 6004-28	BOREHOLE NO: 2012-1
CLIENT: Stantec Consulting Ltd		DRILL METHOD: Solid Stem Auger	ELEVATION: 685.36 m
OWNER:		LOCATION: As per site plan	
SAMPLE TYPE	<input checked="" type="checkbox"/> SHELBY TUBE	<input checked="" type="checkbox"/> CORE SAMPLE	<input checked="" type="checkbox"/> SPT SAMPLE
BACKFILL TYPE	<input checked="" type="checkbox"/> BENTONITE	<input checked="" type="checkbox"/> PEA GRAVEL	<input checked="" type="checkbox"/> SLOUGH
		<input checked="" type="checkbox"/> GROUT	<input checked="" type="checkbox"/> DRILL CUTTINGS
			<input checked="" type="checkbox"/> SAND

COMPLETION DEPTH: 11.89 m  
COMPLETION DATE: 12/4/12

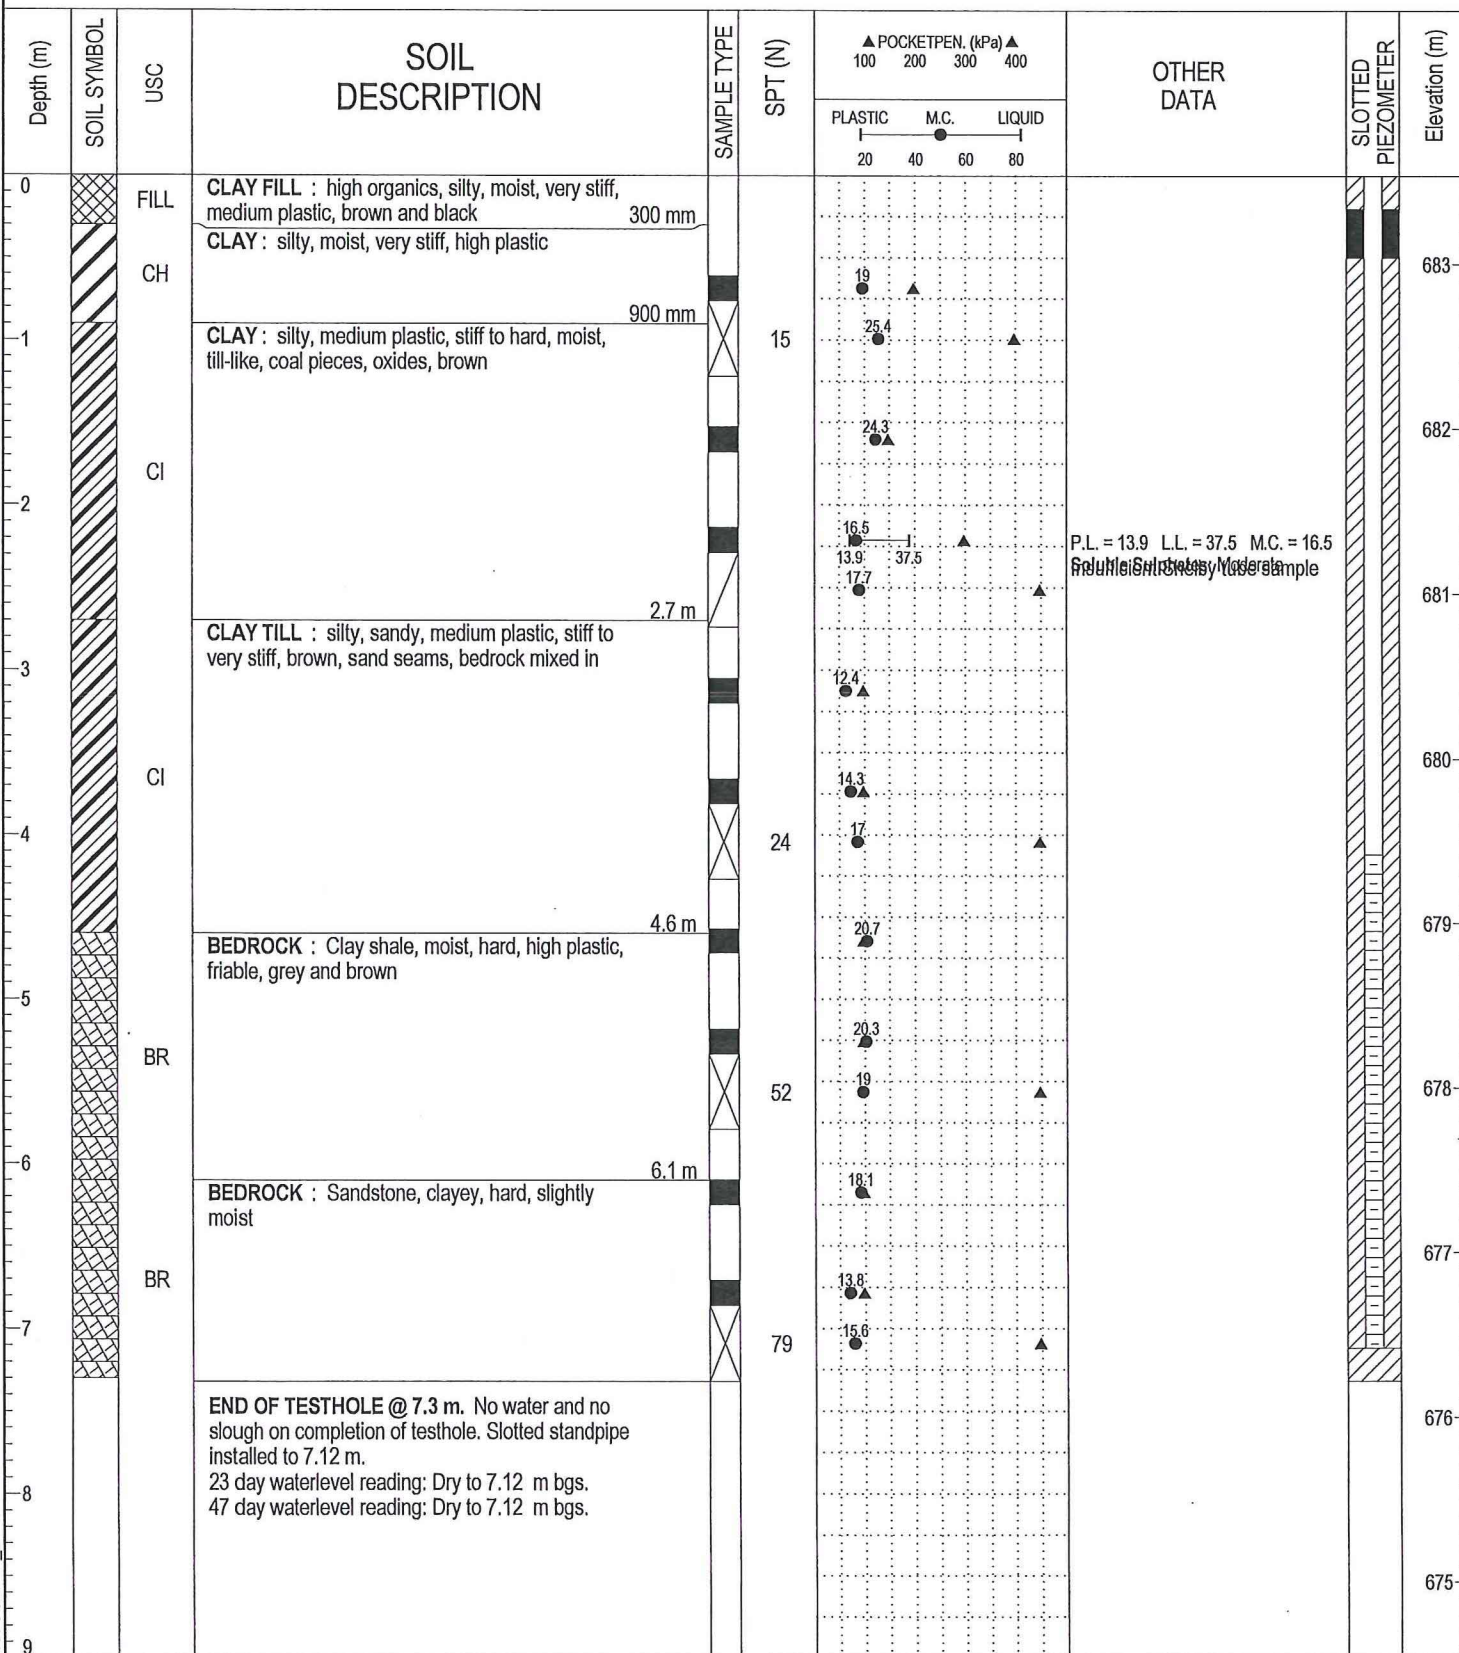
PROJECT: Geotechnical Investigation - Proposed East Schonsee Subdivision		PROJECT NO: 6004-28	BOREHOLE NO: 2012-7
CLIENT: Stantec Consulting Ltd		DRILL METHOD: Solid Stem Auger	ELEVATION: 683.54 m
OWNER:		LOCATION: As per site plan	
SAMPLE TYPE	<input checked="" type="checkbox"/> SHELBY TUBE	<input checked="" type="checkbox"/> CORE SAMPLE	<input checked="" type="checkbox"/> SPT SAMPLE
	<input type="checkbox"/> GRAB SAMPLE	<input type="checkbox"/> NO RECOVERY	
BACKFILL TYPE	<input checked="" type="checkbox"/> BENTONITE	<input type="checkbox"/> PEA GRAVEL	<input type="checkbox"/> SLOUGH
	<input type="checkbox"/> GROUT	<input checked="" type="checkbox"/> DRILL CUTTINGS	<input type="checkbox"/> SAND

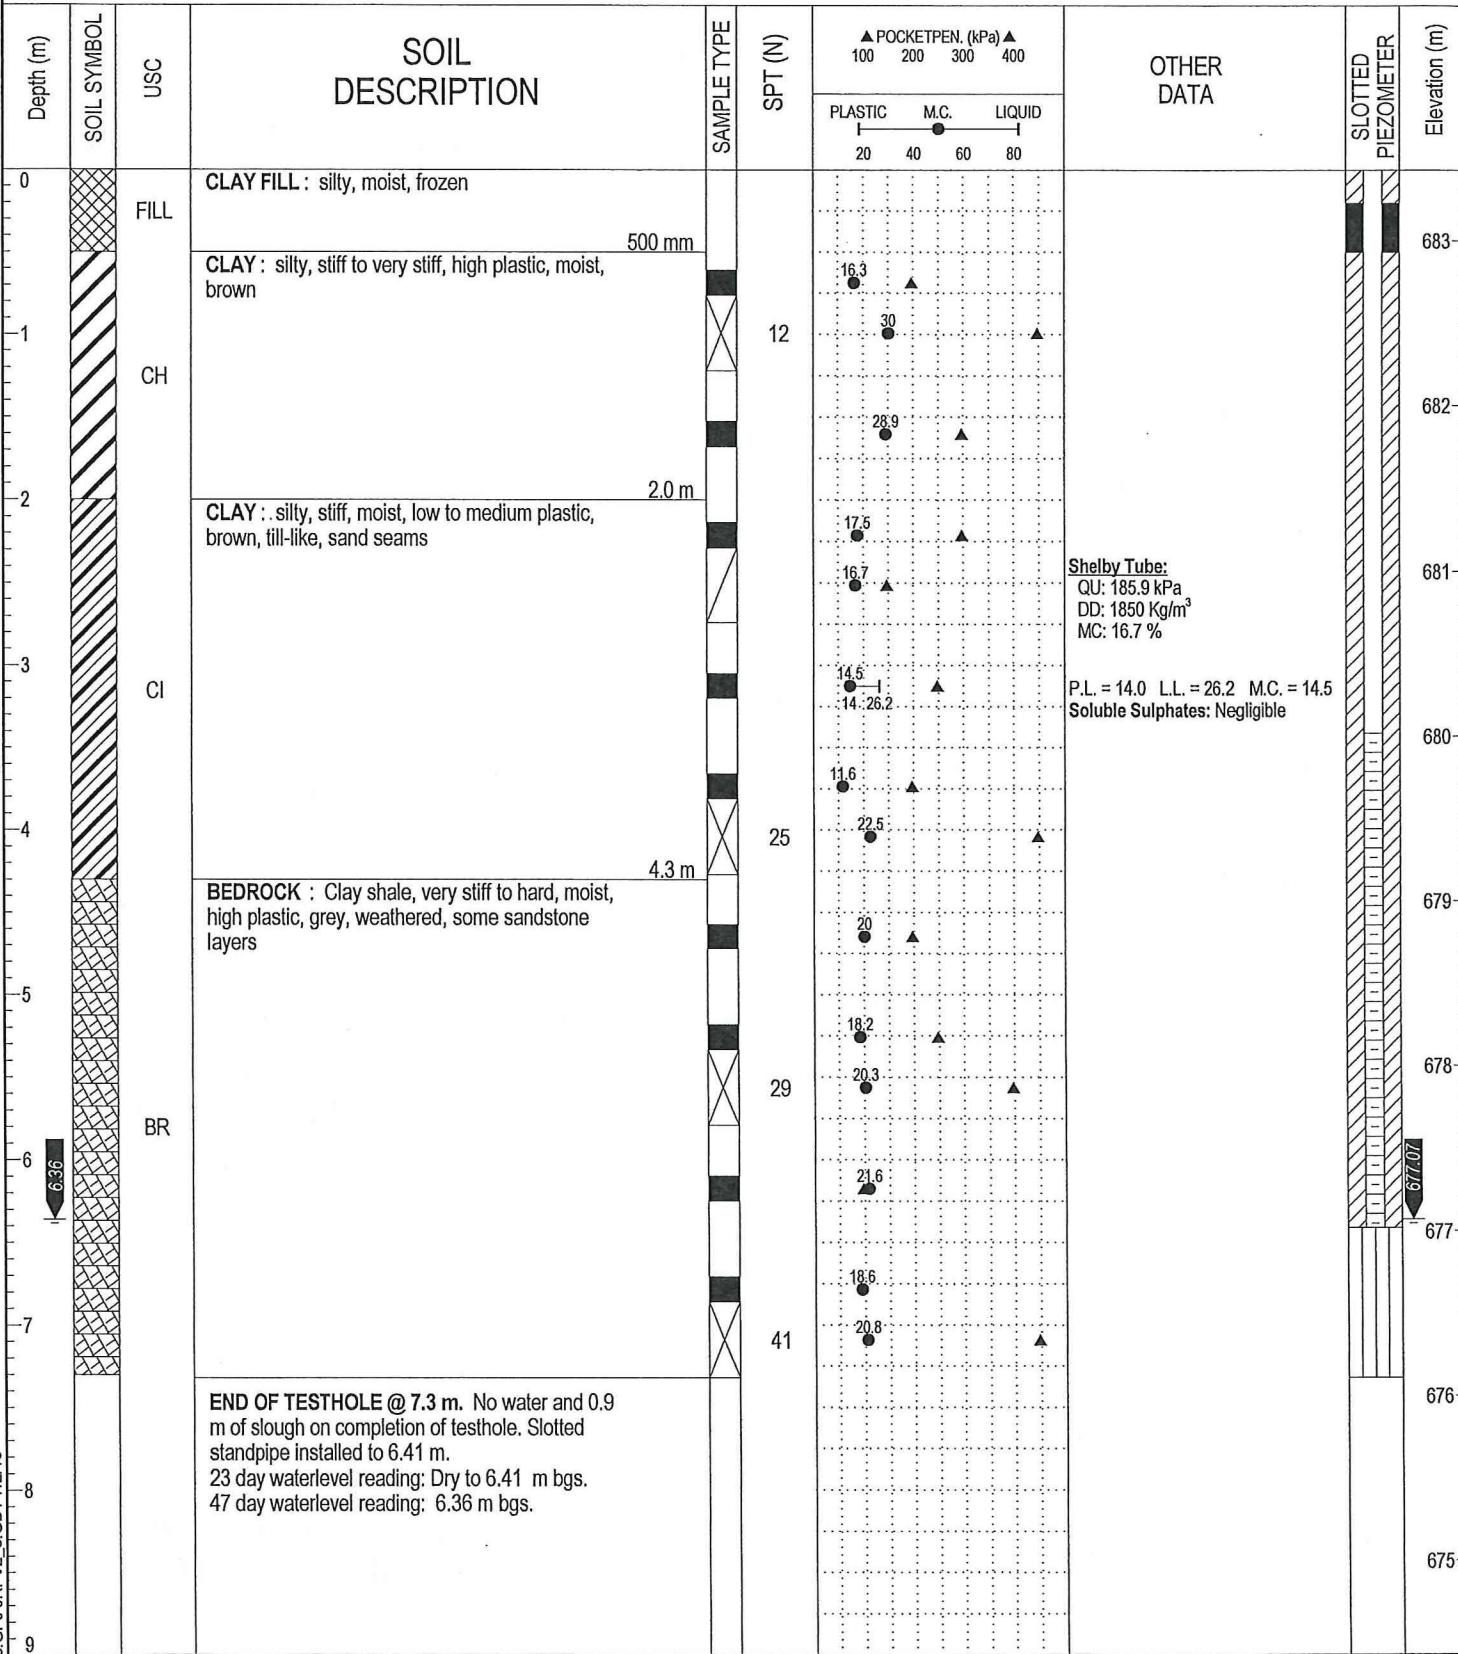
PROJECT: Geotechnical Investigation - Proposed East Schonsee Subdivision		PROJECT NO: 6004-28	BOREHOLE NO: 2012-8
CLIENT: Stantec Consulting Ltd		DRILL METHOD: Solid Stem Auger	ELEVATION: 683.43 m
OWNER:		LOCATION: As per site plan	
SAMPLE TYPE	<input type="checkbox"/> SHELBY TUBE	<input checked="" type="checkbox"/> CORE SAMPLE	<input checked="" type="checkbox"/> SPT SAMPLE
BACKFILL TYPE	<input checked="" type="checkbox"/> BENTONITE	<input type="checkbox"/> PEA GRAVEL	<input type="checkbox"/> SLOUGH
		<input type="checkbox"/> GROUT	<input type="checkbox"/> DRILL CUTTINGS
			<input type="checkbox"/> NO RECOVERY
			<input type="checkbox"/> SAND

COMPLETION DATE: 12/5/12

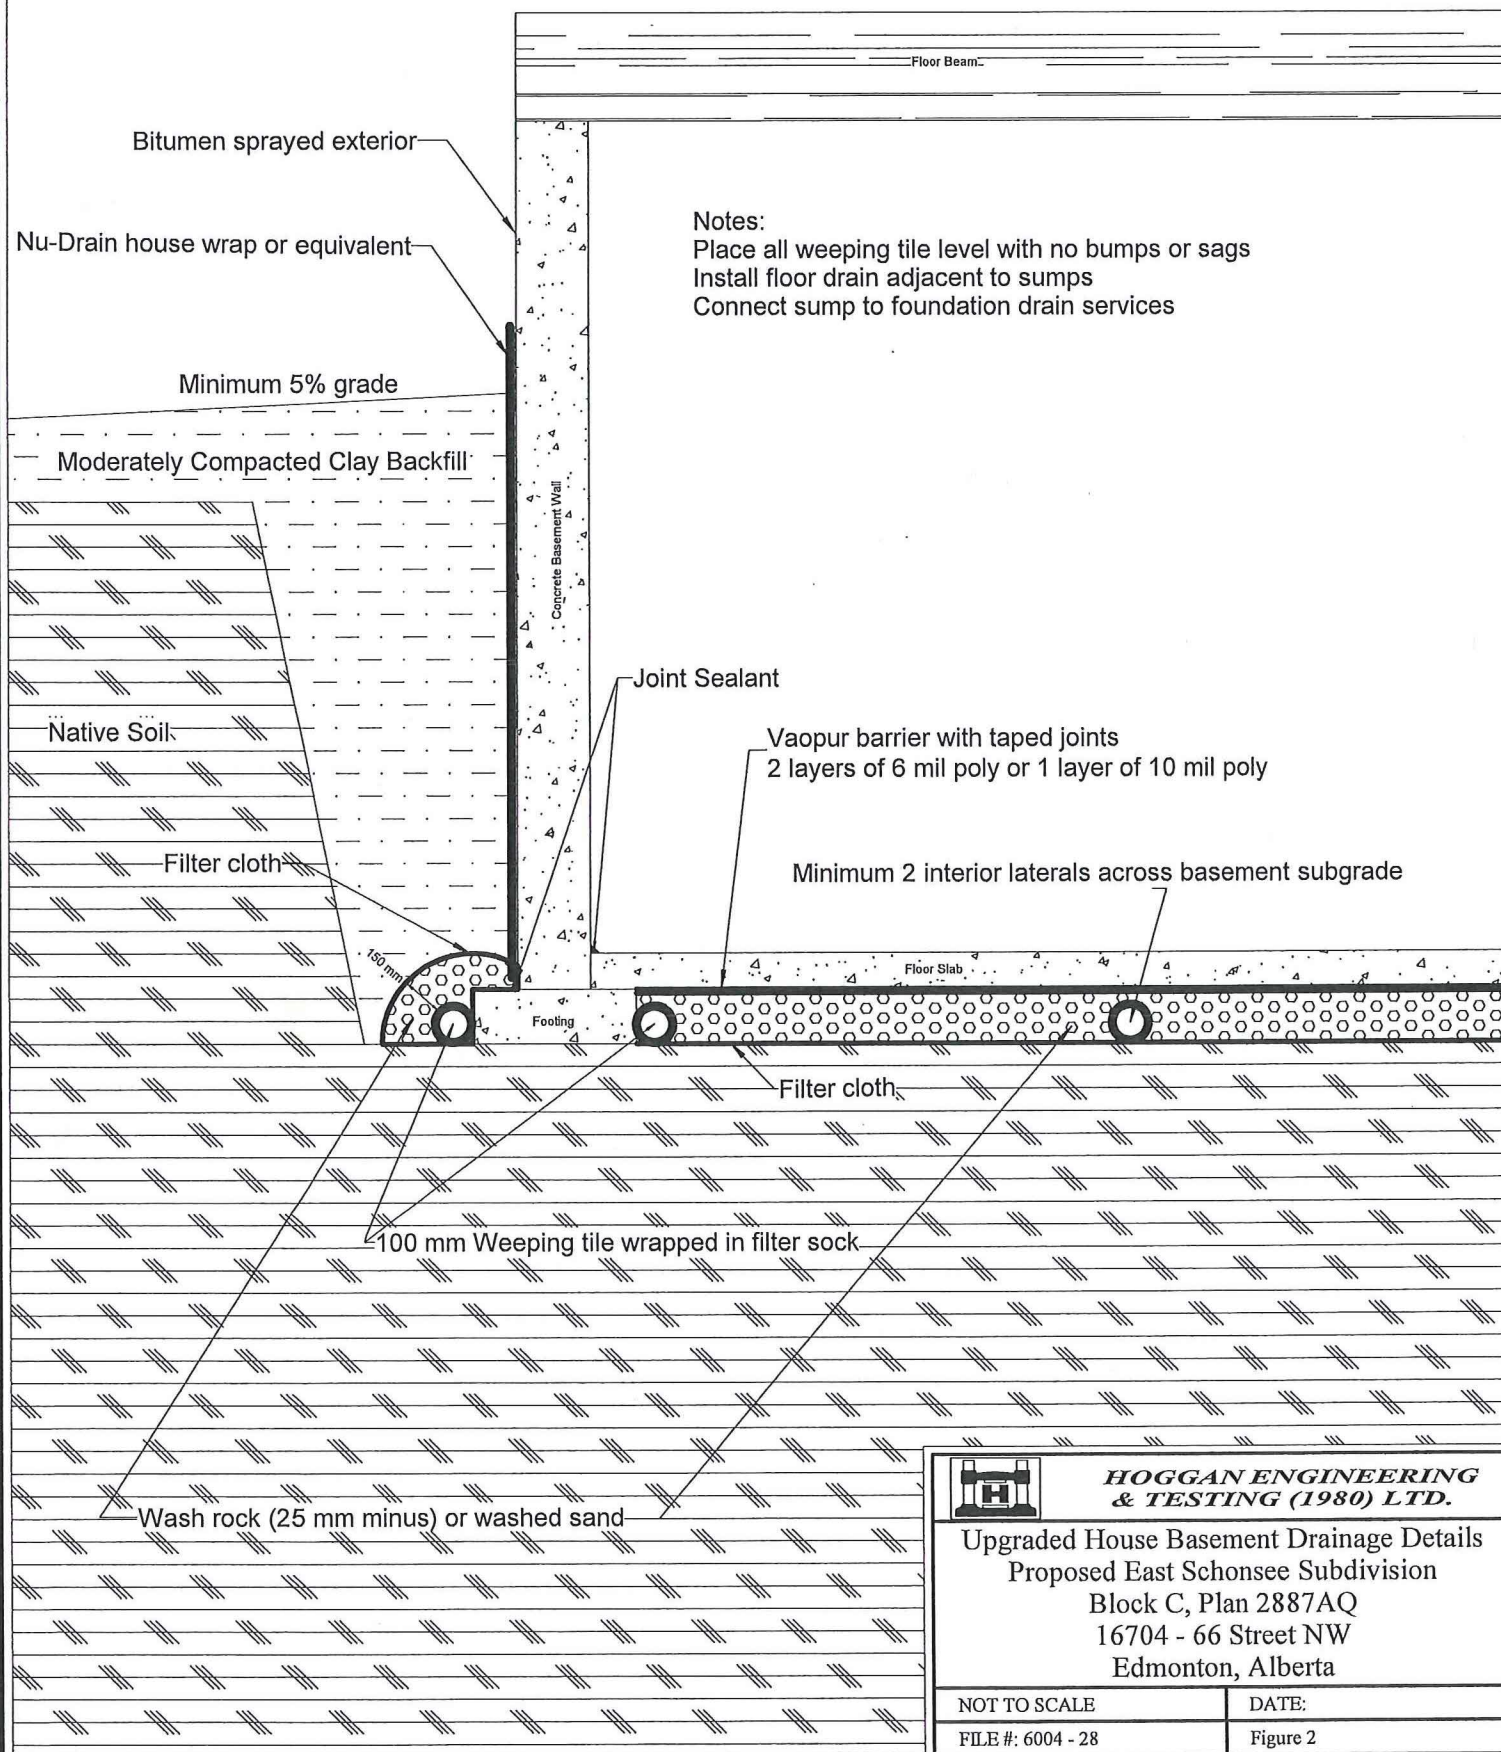
Upgraded House Basement Drainage Details  
Proposed East Schonsee Subdivision  
Block C, Plan 2887AQ  
16704 - 66 Street NW  
Edmonton, Alberta

Where house basements and footing foundations are near the watertable, upgraded foundation drain services to include a washed rock slab base, as well as interior and exterior weeping tile would be required. A schematic drawing depicting the recommended drainage measures is attached. Frequent pump operations should also be expected. The need for upgraded foundation drain services should be determined on a lot by lot basis.
